**Flood Control Project Maintenance
Levee Inspections**
LMA District Cover Sheet
Spring 2020 Levee Inspection Results

Sutter Maintenance Yard East Levee Sacramento River

Spring 2020 Levee Inspection Results

| Waterway | | | Bank | Unit Miles |
|--|---|---|---|---|
| Unit No. 01 Sacramento River | | | Left | 19.85 |

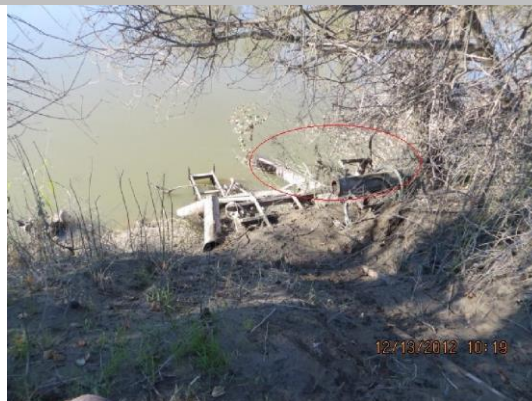
Photo 3 of 3 : UCIP_SP_2020_56043_47078.jpg

WS view: overview of pipe

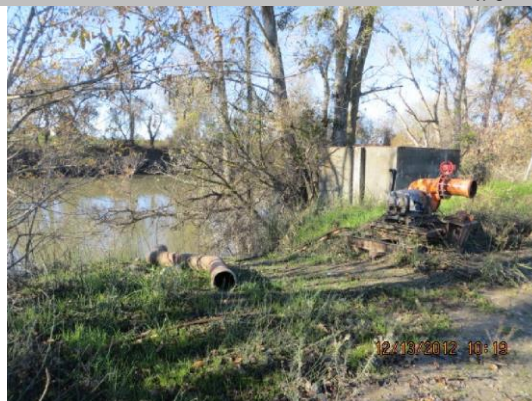
Photo 2 of 3 : UCIP_SP_2020_56070_47086.jpg

| DS_ID:17484 FS_ID:56070 EP_NO: N/A Repair Type: Non-Urgent Crossing Status: Found UCIP Comments: 07/30/2019 Record remains Non-Urgent, pipe has been abandoned. Pipe system found on the WS appears to be abandoned. Need to audit record to determine current owner of pipe system. If pipe system is no longer in use owner will need to coordinate with the CVFPB to properly remove or abandon per Title 23 requirements. (O. Magana - DWR UCIP)04/24/2017 Abandoned-needs to be done so properly. WS underwater during site visit. (DWR Sutter Yard- AFreitag)11/07/2016 Abandoned but needs to be done so properly. (DWR Sutter Yard- AFreitag)09/29/2016 Crossing has been downgraded from Urgent to Non-Urgent crossing is abandoned and WS surge box is full of debris. Need to contact owner and have owner coordinate with CVFPB to comply with Title 23. (DWR UCIP - omagana)06/17/2016 Abandoned crossing. Photo comments updated. (DWR Sutter Yard - afreitag)04/04/2016 Same as last inspection. (DWR UCIP - kfazel)04/06/2015 Crossing appears to be an old irrigation structure and not a drain pipe. It appears abandoned as WS surge box is full of debris. (DWR Sutter Yard - afreitag)06/30/2014 Same as last inspection. (DWR Sutter Yard - afreitag)12/30/2013 Same as last inspection. (DWR Sutter Yard - afreitag)07/29/2013 Same as last inspection. (DWR Sutter Yard - afreitag)12/12/2012 Debris and deteriorated concrete. Gate valve in surge tank. (DWR UCIP - pamatya) FIELD_STRUCT_DESC: *ABANDONED* 24-inch steel irrigation pipe through the levee, invert 26 feet below the crown. Slide gate on the waterside (WS). [Additional Reference(s): USACE Sacramento O&M Manual 136, March 1960 (HLM 4.37)]. FS Date: 7/30/2019 10:57:00 AM | | | | | |

WS view: overview of concrete surge box

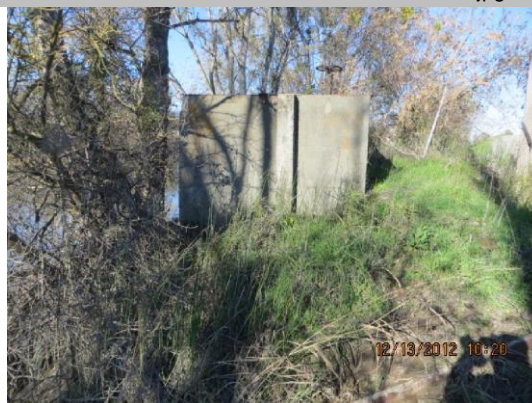
Photo 3 of 3 : UCIP_SP_2020_56070_47085.jpg

WS view: concrete surge box

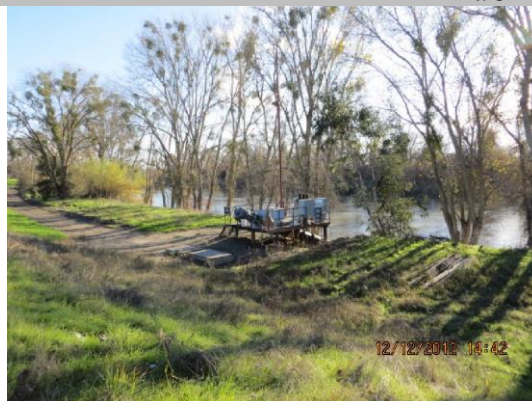
Photo 1 of 3 : UCIP_SP_2020_56027_47092.jpg

DS_ID:17318
FS_ID:56027
EP_NO: 9501
Repair Type: Non-Urgent
Crossing Status: Found
UCIP Comments: 07/30/2019 Record remains Non-Urgent, cover to pipe is missing and poses a safety issue to levee inspectors and the public. Need to contact owner to obtain permit authorizing the modifications to this structure. Recommend auditing record to determine current owner and permit authorizing modifications to structure. (O. Magana - DWR UCIP)04/24/2017 LS shoulder erosion repaired. Not sure if any changes or repairs were done to the pipe itself. (DWR Sutter Yard- AFreitag)11/07/2016 LS erosion still a problem at the LS shoulder. (DWR Sutter Yard- AFreitag)06/06/2016 LS erosion still present and appears to be getting worse. It is only a few inches away from affecting the paved road way. (DWR Sutter Yard - afreitag)04/04/2016 Same as last inspection. Erosion problem is urgently in need of repair. (DWR UCIP - kfazel)04/06/2015 Erosion problem still present near the LS shoulder. If it gets any worse then it may start to affect the road way. Found a siphon breaker on LS. Antenna and pump station on WS. Huge erosion on LS slope. (DWR Sutter Yard - afreitag)06/30/2014 Same as last inspection. (DWR Sutter Yard - afreitag)12/30/2013 Same as last inspection. (DWR Sutter Yard - afreitag)07/29/2013 Erosion near LS shoulder may start affecting the roadway if it gets any worse. 12/12/2012 Found a siphon breaker on LS. Antenna and pump station on WS. Huge erosion on LS slope. (DWR UCIP - pamatya)

WS view: overview

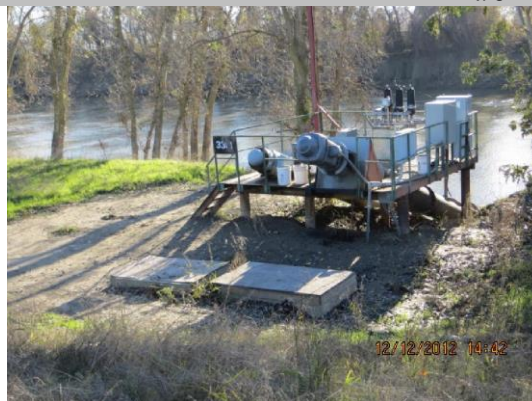
Photo 2 of 3 : UCIP_SP_2020_56027_47091.jpg

WS view: overview of pump station

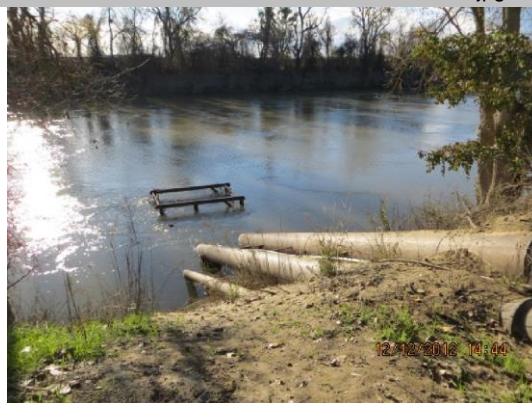
Photo 3 of 3 : UCIP_SP_2020_56027_47096.jpg

WS view: inclined pipes

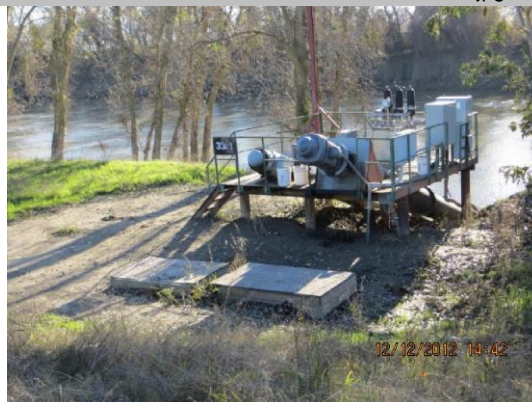
Photo 2 of 3 : UCIP_SP_2020_56029_47100.jpg

| DS_ID:17316 FS_ID:56029 EP_NO: 14137 Repair Type: Non-Urgent Crossing Status: Found UCIP Comments: 07/30/2019 Record remains Non-Urgent, cover to pipe is missing and poses a safety issue to levee inspectors and the public. Need to contact owner to obtain permit authorizing the modifications to this structure. Recommend auditing record to determine current owner and permit authorizing modifications to structure. (O. Magana - DWR UCIP)04/24/2017 Crossing appears to be in good condition. (DWR Sutter Yard- AFreitag)11/07/2016 Crossing appears to be in good condition. (DWR Sutter Yard- AFreitag)06/06/2016 Crossing appears to be in good condition.04/06/2015 No issues present.06/30/2014 Same as last inspection.12/30/2013 Same as last inspection.07/29/2013 Same as last inspection. FIELD_STRUCT_DESC: 30-inch asphalt coated steel irrigation pipe through the levee, invert 4.5 feet below the crown. Inclined pump on the waterside (WS). Siphon breaker on the landside (LS). (Permit No. 14137, 1985 - Butte Creek Farms, Inc.). [Additional Reference(s): DWR Levee Log, 2002]. FS Date: 7/30/2019 10:59:00 AM | | | | | | |

WS view: overview of pumping station

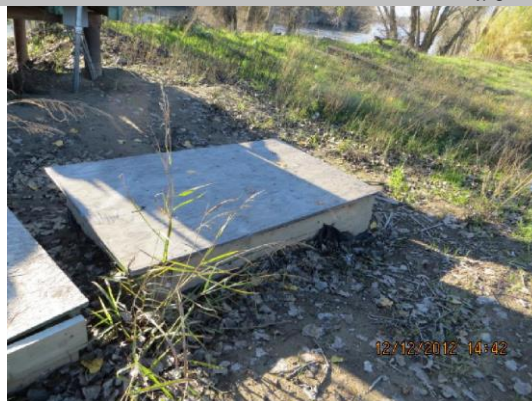
Photo 3 of 3 : UCIP_SP_2020_56029_47099.jpg

WS view: electric box for pump

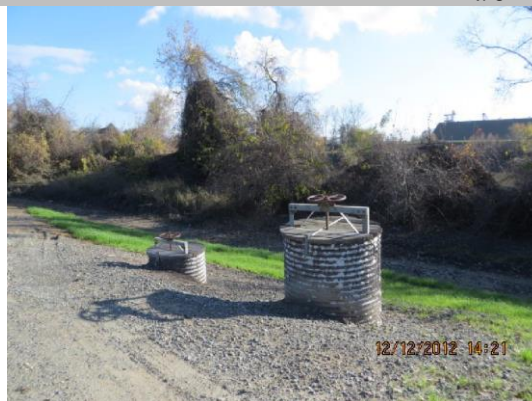
Photo 1 of 3 : UCIP_SP_2020_55526_47107.jpg

DS_ID:17287
FS_ID:55526
EP_NO: 9520
Repair Type: Non-Urgent
Crossing Status: Indicator Found
UCIP Comments: 07/30/2019 Record remains Non-Urgent, pipe has been abandoned. DWR DMP Geophysical Evaluation results indicate possible presence of pipe exists through levee. No other information is available about potential abandoned pipe or method of abandonment. Recommend LMA prepare a contingency plan for increased inspections during high-water to identify any pipe integrity or levee integrity issues that might arise with abandoned pipe. Pipe will need to be removed or abandoned properly as required under Title 23. (O. Magana - DWR UCIP)04/24/2017 Abandoned- needs to be done properly. (DWR Sutter Yard- A Freitag)11/07/2016 appears abandoned and should be done so properly. (DWR Sutter Yard- A Freitag)06/06/2016 Appears to be an abandoned crossing.04/06/2015 Same as last inspection. Still appears abandoned. A concrete standpipe and a CMP riser on WS. It seems abandoned and if so should be done so properly.06/30/2014 Same as last inspection.12/30/2013 Same as last inspection.07/29/2013 Same as last inspection.

FIELD_STRUCT_DESC: *ABANDONED* 24-inch corrugated metal drainage pipe through the levee, 17 feet below the crown, not found in 2015. Slide gate in a corrugated metal pipe (CMP) riser on the waterside (WS) slope, found in 2015. Pump on the WS bank and concrete standpipe on the WS berm, found in 2015. 18-inch concrete pipe from standpipe at WS toe. Pipe discharges into a field on the landside (LS), not found in 2015. (24-inch pipe [HLM 4.99] authorized under Automatic Board Order (ABO) issued as Permit No. 9520, 1974 - Arnold). [Additional Reference(s): DWR Levee Log, 2002. USACE Sacramento O&M Manual 136, March 1960 (HLM 4.99)].
FS Date: 7/30/2019 11:00:00 AM

WS view: overview

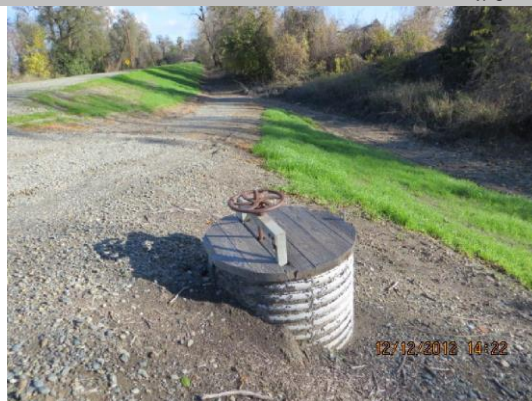
Photo 2 of 3 : UCIP_SP_2020_55526_47106.jpg

WS view: CMP riser with slide gate

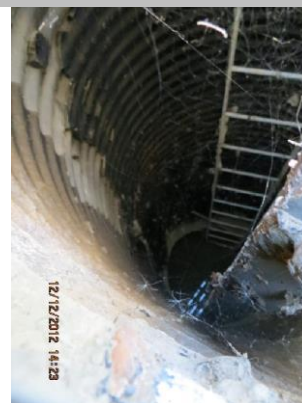
Photo 3 of 3 : UCIP_SP_2020_55526_47105.jpg

WS view: inside CMP riser

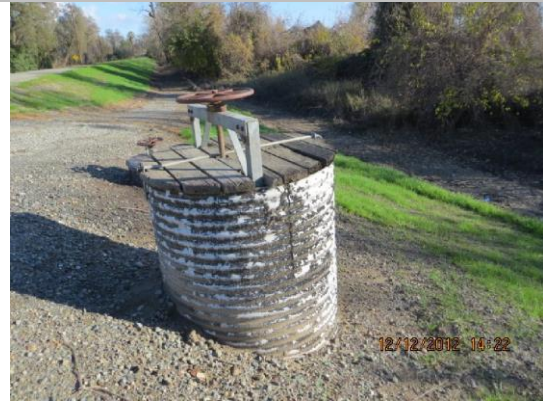
Photo 2 of 3 : UCIP_SP_2020_55527_47111.jpg

WS view: CMP riser with slide gate

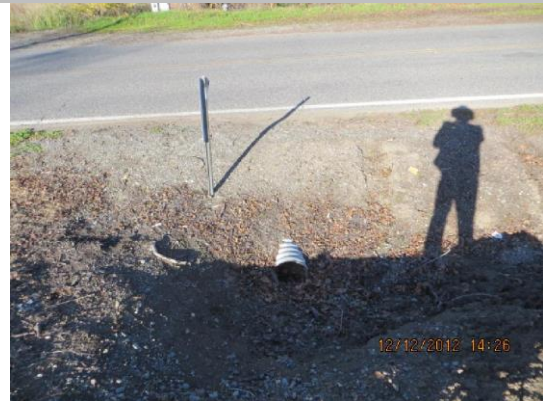
Photo 3 of 3 : UCIP_SP_2020_55527_47110.jpg

LS view: overview- county road and road drainpipe

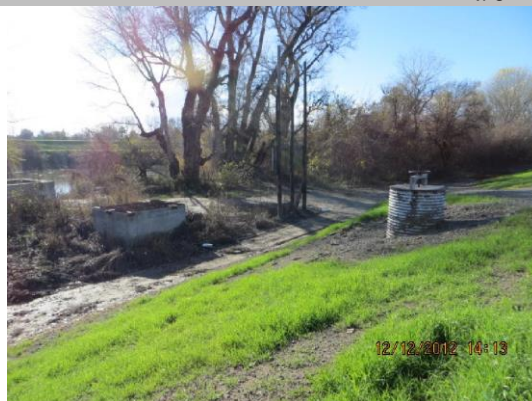
Photo 1 of 3 : UCIP_SP_2020_55529_47115.jpg

DS_ID:17289
FS_ID:55529
EP_NO: N/A
Repair Type: Non-Urgent
Crossing Status: Found
UCIP Comments: 07/30/2019 Record remains Non-Urgent, pipe has been abandoned. No other information is available about potential abandoned pipe or method of abandonment. Recommend LMA prepare a contingency plan for increased inspections during high-water to identify any pipe integrity or levee integrity issues that might arise with abandoned pipe. Pipe will need to be removed or abandoned properly as required under Title 23. (O. Magana - DWR UCIP)04/24/2017
Appears abandoned- needs to be done so properly. Sloughing still present near WS surge box. (DWR Sutter Yard- AFreitag)11/07/2016
Appears abandoned but needs to be done so properly. (DWR Sutter Yard- AFreitag)06/06/2016 Sink holes appear to have been repaired but there is still some minor sloughing around the WS surge box. Surge box was full of water at time of inspection and I could not see the pipe inside to see if it still looked corroded and rusty.04/04/2016

Could not find sink holes as in 07/2013 photo. Appears repaired, but sloughing still present around surge box. Need confirmation that pipe was abandoned properly.04/06/2015 Repairs are in progress to this crossing. Surge box on WS and distribution box across the county road on LS. Abandoned pump station and electrical panel on WS. A concrete pump pit on WS.06/30/2014 Sink hole near WS surge box is still present. Portable pumps were lowered down the WS bank and were pumping water directly into WS standpipe on to by pass the surge box.12/30/2013 Sink Hole above pipe on WS still present. Pipe end inside of WS surge box shows heavy signs of rust and corrosion. Recommend having an internal camera inspection completed on pipe.07/29/2013 Portable tow-pump lowered down WS berm to water level and is pumping water into concrete surge box on WS and the filling the irrigation ditch on LS. Sink hole with standing water that is present above the outlet pipe for the WS surge box. This may indicate a leaking pipe or cracked concrete.

FIELD_STRUCT_DESC: *ABANDONED* 36-inch corrugated metal irrigation pipe through the levee, 18.4 feet below the crown, not found in 2016. Slide gate in a corrugated metal pipe (CMP) riser on the waterside (WS) shoulder, found in 2016. Pump and concrete pump pit on the WS bank, found in 2013. Concrete surge box on the WS berm, found in 2016. Pipe discharges into an irrigation ditch on the landside (LS). (Levee Log references Permit No. 2904, 1958 - Butte Creek Farms, Inc. This permit authorizes an existing pump house and makes no mention of this pipe and its appurtenances). [Additional Reference(s): DWR Levee Log, 2002. USACE Sacramento O&M Manual 136, March 1960 (HLM 5.00)]
FS Date: 7/30/2019 11:01:00 AM

WS view: overview

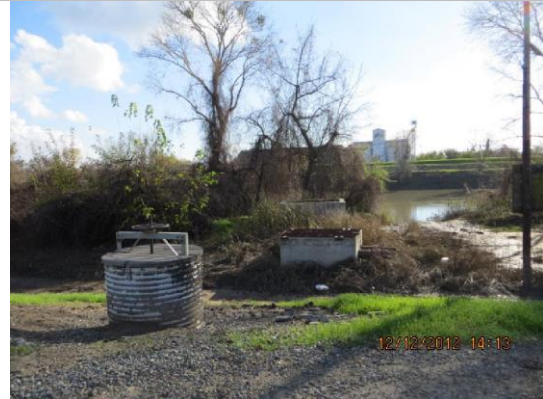
Photo 2 of 3 : UCIP_SP_2020_55529_47113.jpg

WS view: CMP riser and surge box

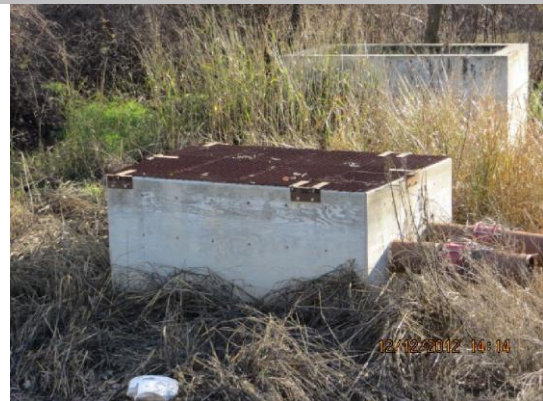
Photo 3 of 3 : UCIP_SP_2020_55529_47114.jpg

WS view: closer look at surge box

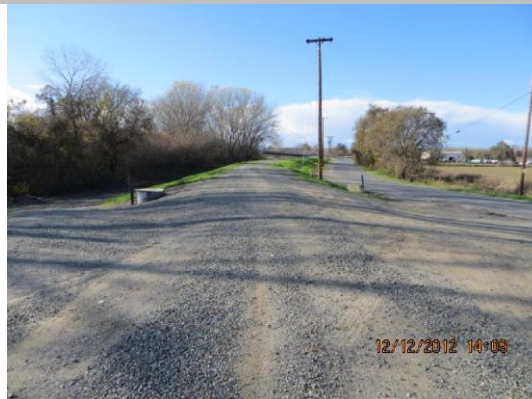
Photo 1 of 3 : UCIP_SP_2020_56032_47123.jpg

DS_ID:17290
FS_ID:56032
EP_NO: 9530
Repair Type: Non-Urgent
Crossing Status: Indicator Found
UCIP Comments: 07/30/2019 Record has been updated from No Action Needed to Non-Urgent, pipe has been abandoned. No other information is available about potential abandoned pipe or method of abandonment. Recommend LMA prepare a contingency plan for increased inspections during high-water to identify any pipe integrity or levee integrity issues that might arise with abandoned pipe. Pipe will need to be removed or abandoned properly as required under Title 23. Need to audit record to clarify owner for this pipe. (O. Magana - DWR UCIP)04/24/2017 Abandoned- needs to be done properly. (DWR Sutter Yard- AFreitag)11/07/2016 Abandoned and should be done so properly. (DWR Sutter Yard- AFreitag)06/06/2016 Appears to be an abandoned crossing. Only the riser was found on the WS.04/06/2015 Same as last inspection. Only cmp riser found of WS.Only CMP riser found on WS. Buried/blocked culvert found across county road.06/30/2014 Same as last inspection.12/30/2013 Same as last inspection.07/29/2013 Same as last inspection.

FIELD_STRUCT_DESC: *ABANDONED* 16-inch concrete encased steel irrigation pipe through the levee, 12 feet below the crown, not found in 2015. Slide gate in a corrugated metal pipe (CMP) riser on the waterside (WS) slope, found in 2015. Pump on the WS bank, not found in 2015. Switch panel on the WS berm. Landside (LS) end of the pipe crosses through a 4-foot by 4-foot concrete box culvert under the county road. (16-inch pipe [HLM 5.01] authorized under Automatic Board Order (ABO) issued as Permit No. 9530, 1974 - Halsey). [Additional Reference(s): DWR Levee Log, 2002. USACE Sacramento O&M Manual 136, March 1960 (HLM 5.01)].
FS Date: 7/30/2019 11:03:00 AM

Crown view: overview of both sides of the levee

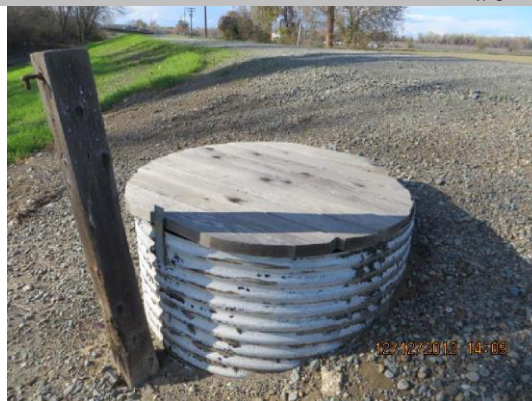
Photo 2 of 3 : UCIP_SP_2020_56032_47122.jpg

WS view: CMP riser

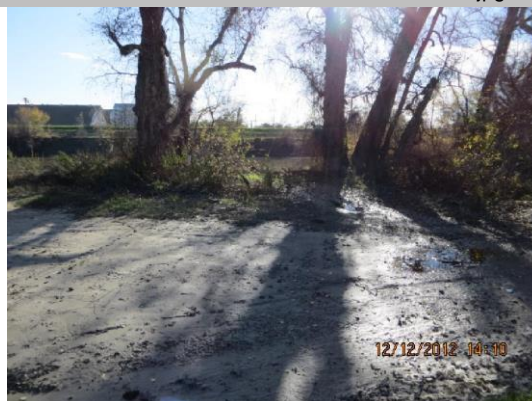
Photo 3 of 3 : UCIP_SP_2020_56032_47125.jpg

WS view: berm and bank

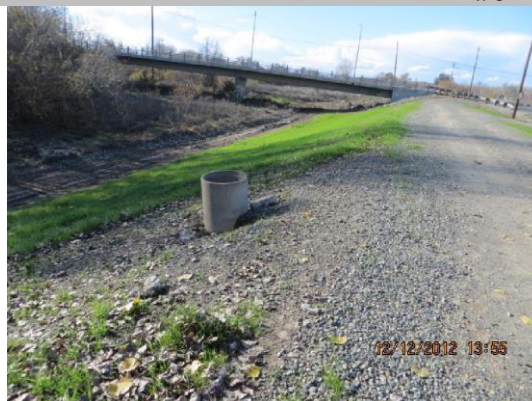
Photo 1 of 3 : UCIP_SP_2020_55532_47127.jpg

| DS_ID:17291 FS_ID:55532 EP_NO: 4091 Repair Type: Non-Urgent Crossing Status: Found UCIP Comments: 07/30/2019 Record remains Non-Urgent, pipe has been abandoned. No other information is available about potential abandoned pipe or method of abandonment. Recommend LMA prepare a contingency plan for increased inspections during high-water to identify any pipe integrity or levee integrity issues that might arise with abandoned pipe. Pipe will need to be removed or abandoned properly as required under Title 23. (O. Magana - DWR UCIP)04/24/2017 Abandoned- needs to be done properly. (DWR Sutter Yard-AFreitag)11/07/2016 Abandoned and should be done so properly. (DWR Sutter Yard- AFreitag)06/06/2016 Appears to be an abandoned crossing. WS was to over grown with vegetation to access the area where the WS pump structure was previously found.04/06/2015 Same as last inspection. Crossing appears abandoned. Appears abandoned and if so should be done so properly. No Siphon breaker found on LS.06/30/2014 Same as last inspection.12/30/2013 Same as last inspection.07/29/2013 Same as last inspection. FIELD_STRUCT_DESC: *ABANDONED* 8-inch asphalt coated steel irrigation pipe through the levee, 4 feet below the crown. Pump on the waterside (WS) bank. Gate valve in a concrete pipe riser on the WS shoulder. (Permit No. 4091, 1962 - Halsey, Yerxa). [Additional Reference(s): DWR Levee Log, 2002]. FS Date: 7/30/2019 11:04:00 AM | | | | | | |

WS view: concrete pipe riser with gate valve

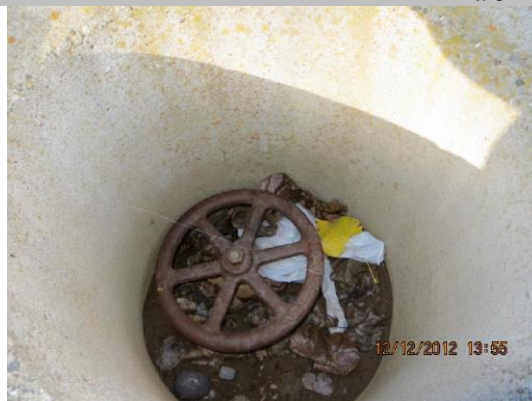
Photo 2 of 3 : UCIP_SP_2020_55532_47126.jpg

WS view: buried gate valve in concrete pipe riser

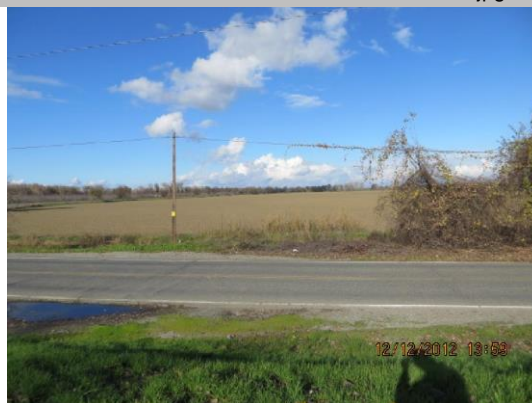
Photo 3 of 3 : UCIP_SP_2020_55532_47128.jpg

LS view: overview

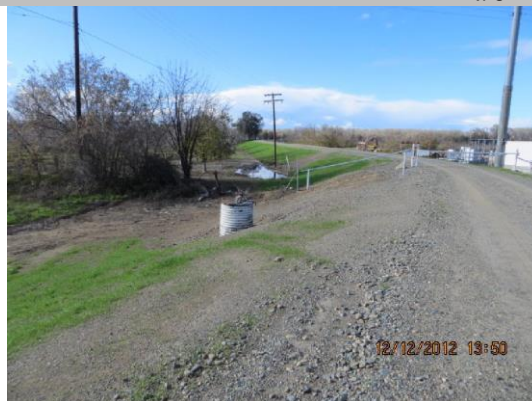
Photo 1 of 3 : UCIP_SP_2020_55533_47132.jpg

DS_ID:17292
FS_ID:55533
EP_NO: N/A
Repair Type: Non-Urgent
Crossing Status: Indicator Found
UCIP Comments: 07/31/2019 Record remains Non-Urgent, pipe has been abandoned. No other information is available about potential abandoned pipe or method of abandonment. Recommend LMA prepare a contingency plan for increased inspections during high-water to identify any pipe integrity or levee integrity issues that might arise with abandoned pipe. Pipe will need to be removed or abandoned properly as required under Title 23. No permit has been identified authorizing this pipe. (O. Magana - DWR UCIP)04/19/2017 Abandoned- needs to be done properly. (DWR Sutter Yard- AFreitag)10/31/2016 Abandoned pipe. (DWR Sutter Yard- AFreitag)06/06/2016 Pipe was internally cleaned and camera inspected on 11/23/2015 by Norcal Pipe Line Services. 80.4 ft of the pipe (starting at the WS end) were inspected to get us through the levee prism but the LS end was never reached or found. Pipe showed some signs of rusting but no visible holes or deformations were found. After the inspection the WS end was capped and reburied until further abandonment can be achieved.04/01/2015 Same as last inspection. Pipe has been selected to be dug up and camera inspected.Only CMP riser with slide gate found on WS.06/30/2014 Same as last inspection.12/18/2013 Same as last inspection.07/23/2013 Same as last inspection.

FIELD_STRUCT_DESC: *ABANDONED* 24-inch corrugated metal drainage pipe through the levee, 15.8 feet below the crown, not found in 2015. Slide gate in a corrugated metal pipe (CMP) riser on the waterside (WS) slope, found in 2015. Levee Log states that the pipe is plugged on the WS end. [Additional Reference(s): DWR Levee Log, 2002. USACE Sacramento O&M Manual 136, March 1960 (HLM 5.21)].
FS Date: 7/31/2019 8:02:00 AM

WS view: overview

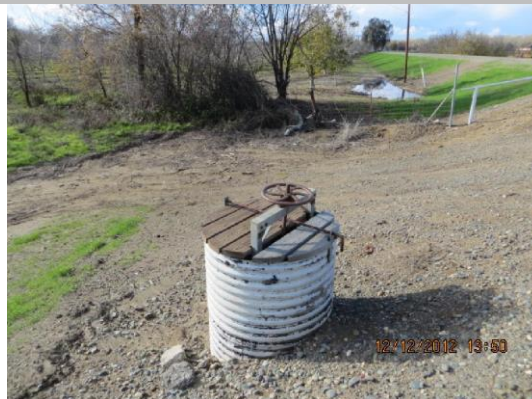
Photo 2 of 3 : UCIP_SP_2020_55533_47131.jpg

WS view: CMP riser with slide gate

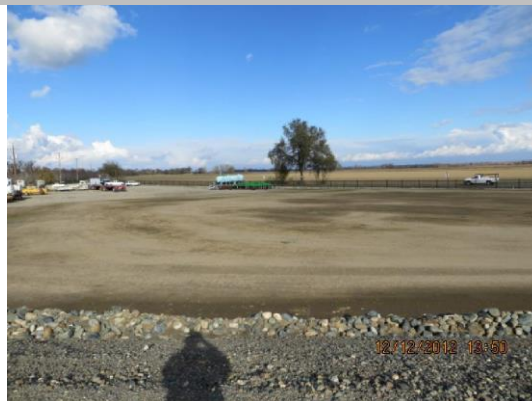
Photo 3 of 3 : UCIP_SP_2020_55533_47130.jpg

LS view: overview (no pipe)

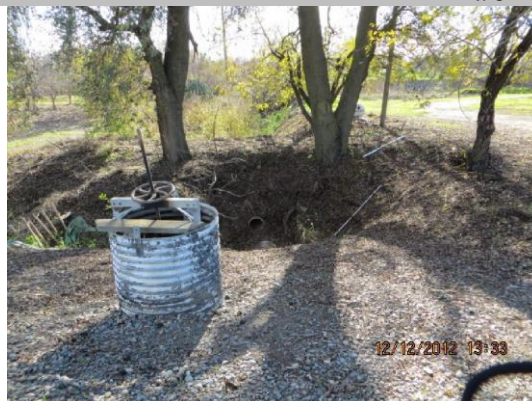
Photo 1 of 3 : UCIP_SP_2020_55534_47136.jpg

DS_ID:17293
FS_ID:55534
EP_NO: 9514
Repair Type: Non-Urgent
Crossing Status: Found
UCIP Comments: 07/31/2019 Record has been updated from No Action Needed to Non-Urgent, pipe has been modified. No permit was found authorizing modifications to pipe. Need to contact owner to determine permit authorizing modifications to pipe. Recommend auditing ABO to confirm owner. (O. Magana - DWR UCIP)04/19/2017 Crossing appears to be in good condition. (DWR Sutter Yard- Afreitag)10/31/2016 Crossing appears to be in good condition. (DWR Sutter Yard- Afreitag)06/06/2016 New shut off valve was installed on the pvc pipe inside of the WS standpipe and the slide gate there was removed.04/04/2016 Annular space between sleeved pipe and CMP has been grouted. 04/01/2015 PVC pipe still runs through crossing. WS end has been covered and blocked with sandbags to prevent water flow during high water season.06/30/2014 Same as last inspection.- Water transfer ditch and CMP riser on WS12/18/2013 Same as last inspection. Levee inspections is working with land owner to solve this issue.07/23/2013 8inch pvc running through pipe preventing slide gate from closing. No positive pipe closure for high water season. Stem on WS screw gate is bent. FIELD_STRUCT_DESC: 24-inch corrugated metal irrigation pipe through the levee, invert 11 ft below the crown. 8-inch polyvinyl chloride (PVC) pipe sleeved through the 24-inch corrugated metal pipe (CMP) with the annular space grouted. Slide gate in a CMP riser on the waterside (WS) slope. Concrete headwall on the WS berm, pump on the WS bank. Discharges into a field at the landside (LS) toe. Irrigation ditch across WS berm to headwall. (Automatic Board Order (ABO) issued as Permit No. 9514, 1974 - Boggs). [Additional Reference(s): DWR Levee Log, 2002. USACE Sacramento O&M Manual 136, March 1960 (HLM 5.39)]

WS view: CMP riser with slide gate

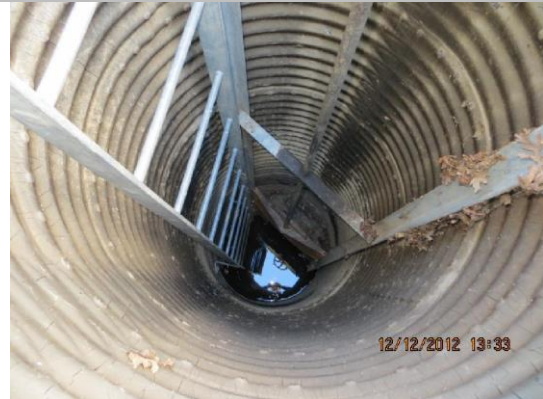
Photo 2 of 3 : UCIP_SP_2020_55534_47135.jpg

WS view: inside CMP riser

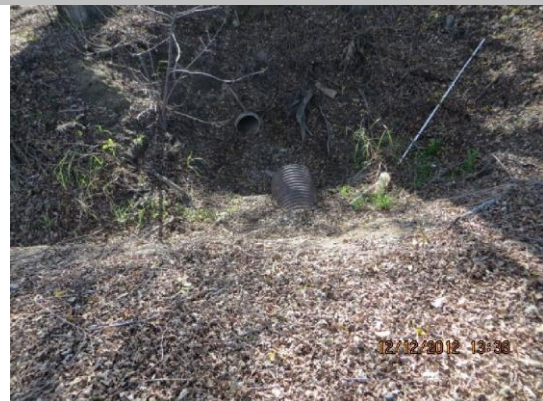
Photo 3 of 3 : UCIP_SP_2020_55534_47134.jpg

WS view: water transfer ditch

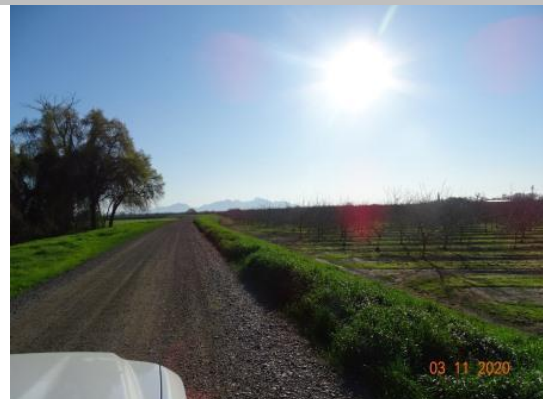
Photo 1 of 1 : SP_2020_ST0003_264_137_20200313_00280.jpg

View of the vegetation along the landside slope. Spring 2020.

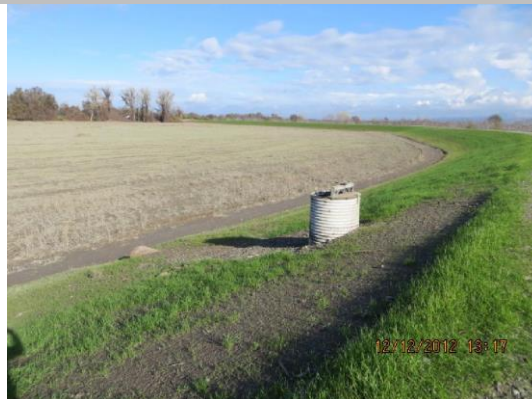
Photo 1 of 3 : UCIP_SP_2020_55535_47149.jpg

DS_ID:17294
FS_ID:55535
EP_NO: 9514
Repair Type: Non-Urgent
Crossing Status: Found
UCIP Comments: 07/31/2019 Record has been updated from No Action Needed to Non-Urgent, pipe has been modified. No permit was found authorizing modifications to 30-inch pipe. Need to contact owner to determine permit authorizing medications to pipe. Recommend auditing ABO to confirm owner. (O. Magana - DWR UCIP)04/19/2017 Crossing appears to be in good condition. (DWR Sutter Yard- Afreitag)10/31/2016 Crossing appears to be in good condition. (DWR Sutter Yard- Afreitag)06/01/2016 Slide gate was removed from the WS riser and the riser was then filled up with concrete as the rest of the 36" cmp was pressure grouted.04/04/2016 Void between new 8-inch pipe and 36-inch pipe has been filled with concrete.04/01/2015 PVC pipe still runs through crossing. WS end has been covered and blocked with sandbags to prevent water flow during high water season. 36-inch CMP found instead of 30-inch CMP. LS pipe tampered.06/30/2014 Same as last inspection.12/18/2013 Same as last inspection. Levee inspections is working with land owner to solve the issue.07/23/2013 8inch PVC pipe ran through 36inch CMP preventing screw gate from closing for high water season. FIELD_STRUCT_DESC: 36-inch (not 30-inch as noted in the Levee Log, O&M Manual, or Automatic Board Order) corrugated metal irrigation pipe through the levee, 12 feet below the crown. 8-inch polyvinyl chloride (PVC) pipe sleeved through the 36-inch pipe with the annular space grouted. Slide gate (removed in 2016) in a corrugated metal pipe (CMP) riser on the waterside (WS) slope. Well structure off landside (LS) toe possibly associated with this pipe. (Automatic Board Order (ABO) issued as Permit No. 9514, 1974 - Boggs). [Additional Reference(s): DWR Levee Log, 2002. USACE Sacramento O&M Manual 136 (HLM 6.05)].

WS view: overview

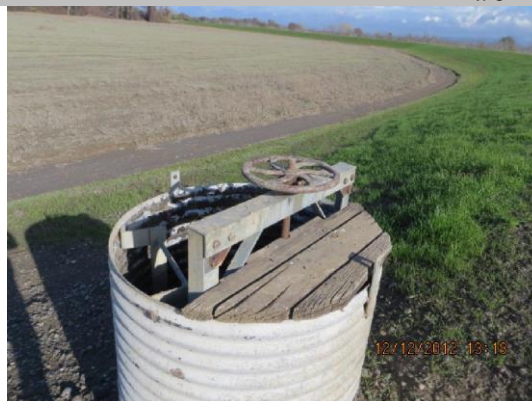
Photo 2 of 3 : UCIP_SP_2020_55535_47147.jpg

WS view: CMP riser with slide gate

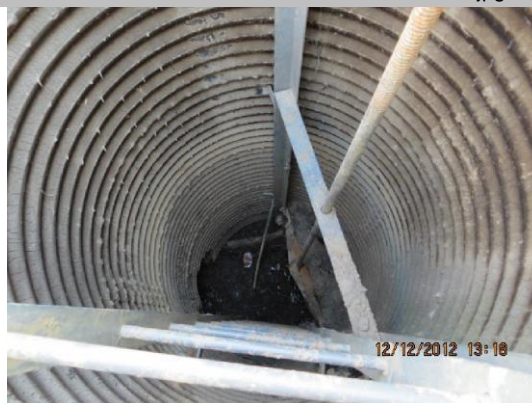
Photo 3 of 3 : UCIP_SP_2020_55535_47148.jpg

WS view: inside CMP riser

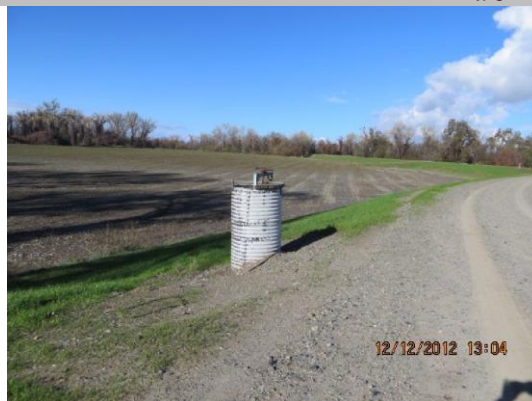
Photo 1 of 3 : UCIP_SP_2020_55536_47158.jpg

DS_ID:17306
FS_ID:55536
EP_NO: 9530
Repair Type: Non-Urgent
Crossing Status: Found
UCIP Comments: 07/31/2019 Record remains Non-Urgent, pipe has been abandoned. DWR DMP Geophysical Evaluation results indicate possible presence of pipe exists through levee. No other information is available about potential abandoned pipe or method of abandonment. Recommend LMA prepare a contingency plan for increased inspections during high-water to identify any pipe integrity or levee integrity issues that might arise with abandoned pipe. (O. Magana - DWR UCIP)04/16/2017 Abandoned- needs to be done properly. (DWR Sutter Yard- A Freitag)10/31/2016 Appears abandoned. (DWR Sutter Yard- A Freitag)06/01/2016 Appears to be an abandoned crossing. WS end is about 90% buried with soil and the LS end is still unknown.04/01/2015 WS pipe end 3/4 blocked by soil. LS end is still unknown. Pipe outlet on WS partially buried, it needs cleaning.06/30/2014 Same as last inspection.12/18/2013 Same as last inspection.07/23/2013 Same as last inspection

WS view: CMP riser with slide gate

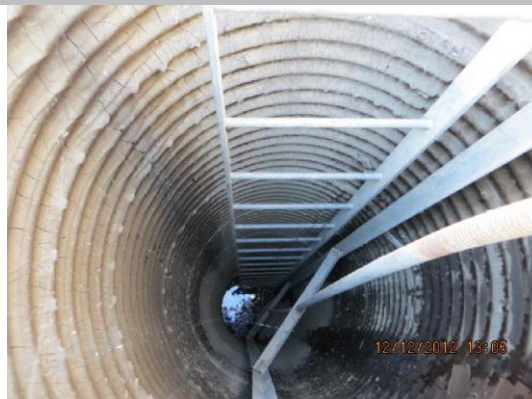
Photo 2 of 3 : UCIP_SP_2020_55536_47156.jpg

WS view: inside CMP riser

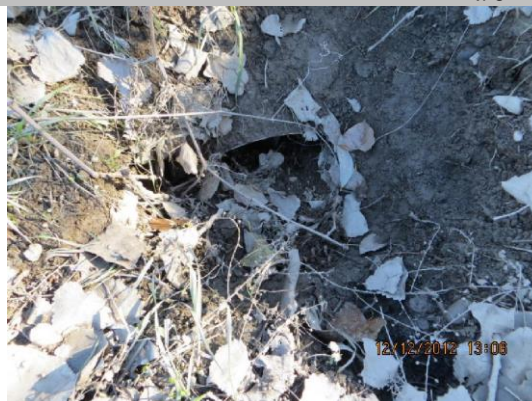
Photo 3 of 3 : UCIP_SP_2020_55536_47157.jpg

WS view: partially burried steel pipe

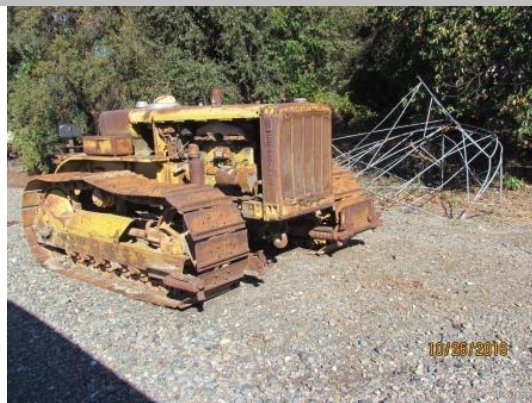
Photo 1 of 1 : SP_2020_ST0003_264_98_20200226_00017.jpg

View of the ag equipment along the landside toe.

| The equipment should be removed from the landside shoulder. | | | | | |

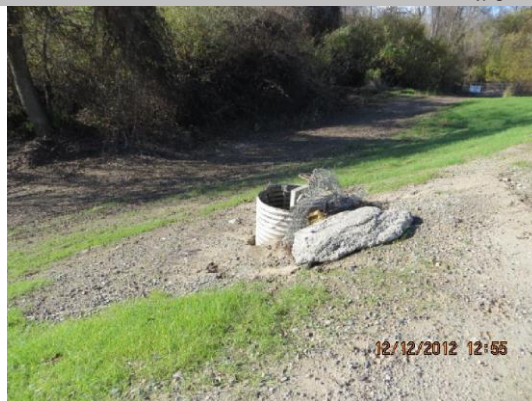
Photo 1 of 3 : UCIP_SP_2020_55537_47181.jpg

| DS_ID:17296 FS_ID:55537 EP_NO: 9530 Repair Type: Non-Urgent Crossing Status: Indicator Found UCIP Comments: 07/31/2019 Record remains Non-Urgent, pipe has been abandoned. DWR DMP Geophysical Evaluation results indicate possible presence of pipe exists through levee. No other information is available about potential abandoned pipe or method of abandonment. Recommend LMA prepare a contingency plan for increased inspections during high-water to identify any pipe integrity or levee integrity issues that might arise with abandoned pipe. (O. Magana - DWR UCIP)04/19/2017 Abandoned- needs to be done properly. (DWR Sutter Yard- A Freitag)10/31/2016 Abandoned. (DWR Sutter Yard- A Freitag)06/01/2016 Abandoned- only WS riser and screw gate found.04/01/2015 Only cmp riser with screw gate found on WS. Screw gate stem is bent.Appears abandoned and should be verified as having been done so properly. Only CMP riser with slide gate found on WS06/30/2014 Same as last inspection.12/18/2013 Same as last inspection.07/23/2013 Same as last inspection FIELD_STRUCT_DESC: *ABANDONED* 24-inch corrugated metal drainage pipe through the levee, 13.5 feet below the crown, not found in 2015. Slide gate in a corrugated metal pipe (CMP) riser on the waterside (WS) slope, found in 2015. (24-inch pipe [HLM 6.61] authorized under Automatic Board Order (ABO) issued as Permit No. 9530, 1974 - Halsey). [Additional Reference(s): DWR Levee Log, 2002. USACE Sacramento O&M Manual 136, March 1960 (HLM 6.61)]. FS Date: 7/31/2019 8:10:00 AM | | | | | |

WS view: CMP riser with slide gate

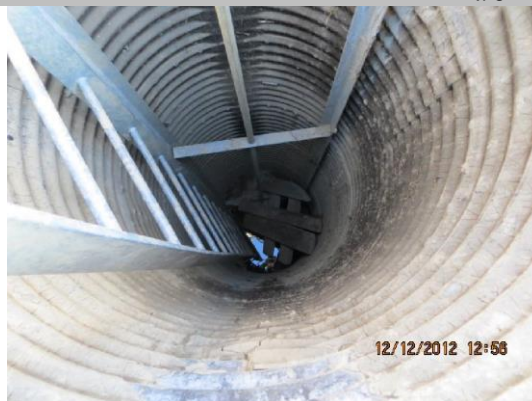
Photo 2 of 3 : UCIP_SP_2020_55537_47180.jpg

WS view: inside CMP riser

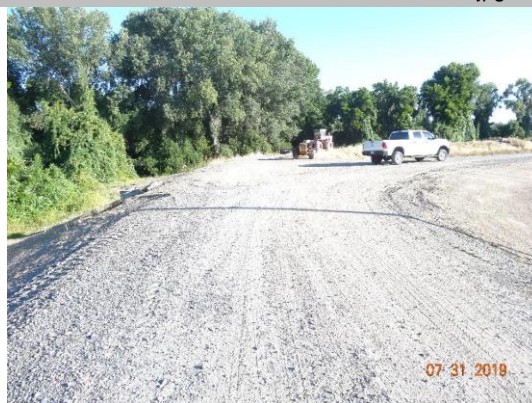
Photo 3 of 3 : UCIP_SP_2020_55537_81856.jpg

Overview of levee crown looking u/s towards pipe crossing.

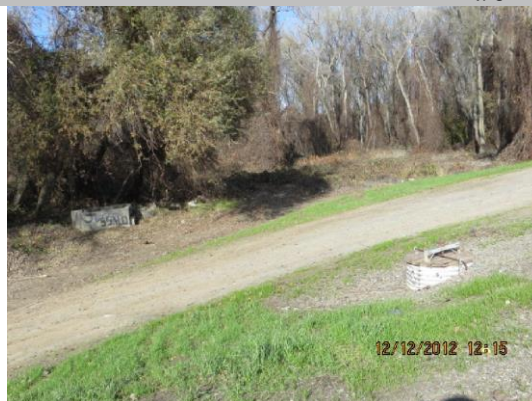
Photo 1 of 3 : UCIP_SP_2020_55542_47189.jpg

DS_ID:17300
FS_ID:55542
EP_NO: N/A
Repair Type: Non-Urgent
Crossing Status: Indicator Found
UCIP Comments: 07/31/2019 Record remains Non-Urgent, pipe has been abandoned and remains through the levee. DWR's geophysical evaluation study indicates signs of pipe are still present through the levee. Recommend LMA monitor this section of the levee for signs of potential pipe or levee integrity issues. This record will remain as part of UCIP's inspection program until funds become available to remove or properly abandon encroachment as required per Title 23. No permit has been identified authorizing the pipe. (O. Magana - DWR UCIP)04/19/2017 Abandoned- needs to be done properly. (DWR Sutter Yard- A Freitag)10/31/2016 Abandoned (DWR Sutter Yard- A Freitag)06/01/2016 Abandoned04/01/2015 Only cmp riser and slide gate found on WS.06/30/2014 Same as last inspection.12/18/2013 Same as last inspection.07/23/2013 Same as last inspection.12/12/2012 Abandoned riser with slide gate on WS. Abandoned concrete surge box on WS. Verify pipe has been abandoned properly. (P. Amatya - DWR UCIP)

FIELD_STRUCT_DESC: *ABANDONED* 24-inch corrugated metal drainage pipe through the levee, 14.5 feet below the crown, not found in 2015. Slide gate in a concrete surge box on the waterside (WS) berm, found in 2015. Slide gate in a corrugated metal pipe (CMP) riser, found in 2015. Pump on the WS slope, not found in 2015. [Additional Reference(s): DWR Levee Log, 2002. USACE Sacramento O&M Manual 136, March 1960 (HLM 7.61)].
FS Date: 7/31/2019 8:22:00 AM

WS view: overview

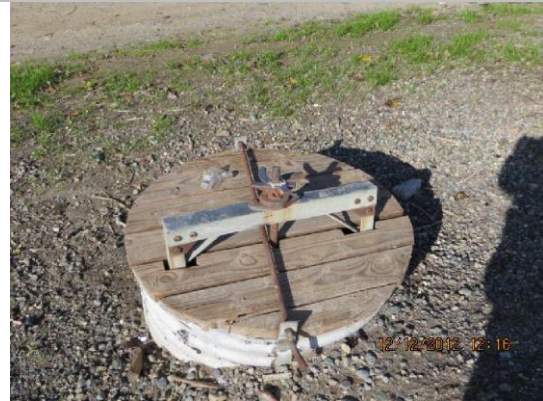
Photo 2 of 3 : UCIP_SP_2020_55542_47188.jpg

WS view: CMP riser with slide gate

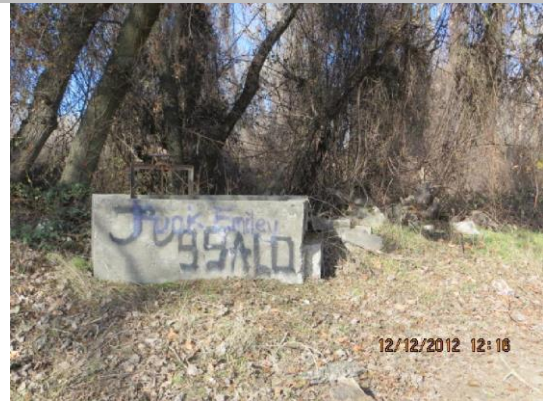
Photo 3 of 3 : UCIP_SP_2020_55542_47192.jpg

WS view: abandoned concrete surge box

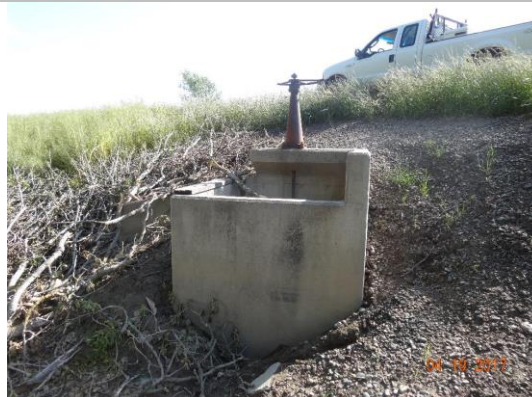
Photo 2 of 3 : UCIP_SP_2020_55543_77009.jpg

| DS_ID:17301 FS_ID:55543 EP_NO: 9532 Repair Type: Non-Urgent Crossing Status: Found UCIP Comments: 07/31/2019 Record remains Non-Urgent, structure has been abandoned. No other information is available about potential abandoned pipe or method of abandonment. Recommend LMA prepare a contingency plan for increased inspections during high-water to identify any pipe integrity or levee integrity issues that might arise with abandoned pipe. No permit has been identified authorizing the pipe. (O. Magana - DWR UCIP)04/19/2017 Abandoned- needs to be done properly(O. Magana - DWR UCIP)04/19/2017 Abandoned-erosion/depression present around the WS box (DWR Sutter Yard-AFreitag)10/31/2016 Abandoned and erosion still present near WS box.(DWR Sutter Yard- A Freitag)06/01/2016 Appears to be an abandoned crossing.04/01/2015 Silted concrete box on WS. Depression/erosion around concrete box on WS.06/30/2014 Same as last inspection.12/18/2013 Same as last inspection.07/23/2013 Same as last inspection.12/12/2012 Silted concrete box on WS. Depression/erosion around concrete box on WS. (P. Amatya - DWR UCIP) FIELD_STRUCT_DESC: *ABANDONED* 36-inch by 48-inch reinforced concrete box drainage culvert through the levee, 11.6 feet below the crown. Slide gate in a concrete box on the waterside (WS) slope. (3-foot by 4-foot culvert [HLM 7.73] authorized under Automatic Board Order (ABO) issued as Permit No. 9532, 1974 - Martin). [Additional Reference(s): DWR Levee Log, 2002. USACE Sacramento O&M Manual 136, March 1960 (HLM 7.73)]. FS Date: 7/31/2019 8:23:00 AM | | | | | | |

Depression around WS concrete box

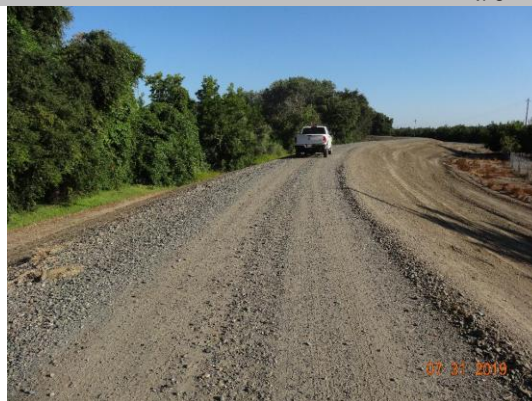
Photo 1 of 3 : UCIP_SP_2020_55544_81876.jpg

DS_ID:17490
FS_ID:55544
EP_NO: N/A
Repair Type: Non-Urgent
Crossing Status: Not Found
UCIP Comments: 07/31/2019 Record has been updated to Non-Urgent due to evidence found of pipe still present through the levee, under DWR DMP Geophysical Investigation, about 62 feet south from original coordinates, 39.241408, -121.994277. Coordinates have been updated from 39.241408, -121.994277 to 39.241222, -121.994241. USACE O&M references pipe as being plugged. Recommend LMA prepare a contingency plan for increased inspections during high-water to identify any pipe integrity or levee integrity issues that might arise with abandoned pipe. Record will remain in UCIP's list as part of future inspections in case any issues arise at this location. (O. Magana - DWR UCIP)04/19/2017 Unable to locate. (DWR Sutter Yard-AFreitag)10/31/2016 Unable to locate.(DWR Sutter Yard-AFreitag)06/01/2016 Unable to locate.04/01/2015 Unable to locate.06/30/2014 Unable to locate.12/18/2013 Unable to locate.07/23/2013 Same as last inspection. Unable to locate.

Overview of levee looking u/s towards where pipe should be buried.

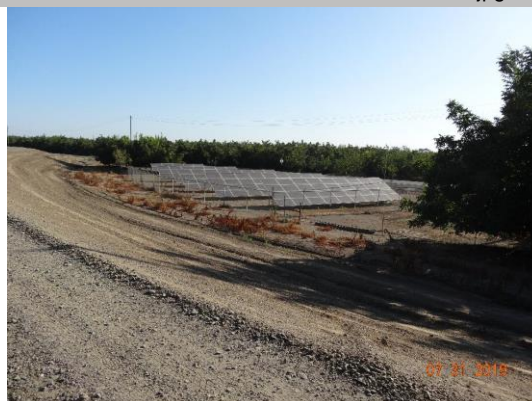
Photo 2 of 3 : UCIP_SP_2020_55544_81877.jpg

LS view: overview of LS, looking photo 1 of 2.

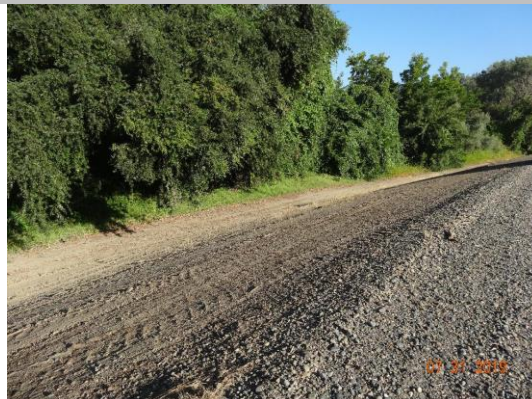
Photo 3 of 3 : UCIP_SP_2020_55544_81878.jpg

WS view: overview of WS.

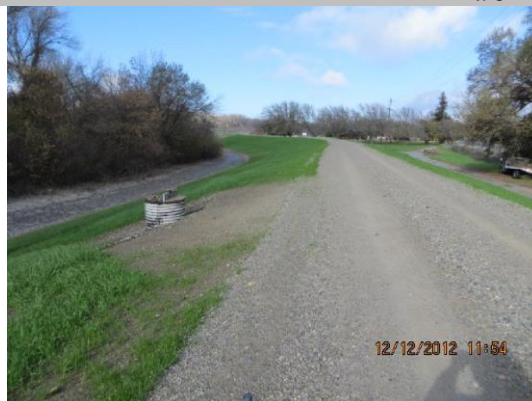
Photo 1 of 3 : UCIP_SP_2020_55545_47199.jpg

| DS_ID:17302 FS_ID:55545 EP_NO: 9529 Repair Type: Non-Urgent Crossing Status: Indicator Found UCIP Comments: 07/31/2019 Record has been updated to Non-Urgent due to evidence found of pipe still present through the levee under the DWR DMP Geophysical Investigation. Recommend LMA prepare a contingency plan for increased inspections during high-water to identify any pipe integrity or levee integrity issues that might arise with abandoned pipe. Record will remain in UCIP's list as part of future inspections until pipe is properly removed or abandoned properly per Title 23 requirements. (O. Magana - DWR UCIP)04/19/2017 Abandoned- needs to be done properly. (DWR Sutter Yard-AFreitag)10/31/2016 Abandoned (DWR Sutter Yard-AFreitag)06/01/2016 Appears abandoned- only WS riser found04/01/2015 Only cmp riser and slide gate found on WS.06/30/2014 Same as last inspection.12/18/2013 Same as last inspection.07/23/2013 Same as last inspection.12/12/2012 Only a CMP riser with slide gate found on WS. FIELD_STRUCT_DESC: 24-inch corrugated metal drainage pipe through the levee, 14.8 feet below the crown, not found in 2015. Slide gate in a 36-inch corrugated metal pipe (CMP) riser on the waterside (WS) shoulder, found in 2015. (24-inch pipe [HLM 8.05] authorized under Automatic Board Order (ABO) issued as Permit No. 9529, 1974 - Dorwood Ranching Company). [Additional Reference(s): DWR Levee Log, 2002. USACE Sacramento O&M Manual 136, March 1960 (HLM 8.05)]. FS Date: 7/31/2019 8:24:00 AM | | | | | |

WS view: CMP riser with slide gate

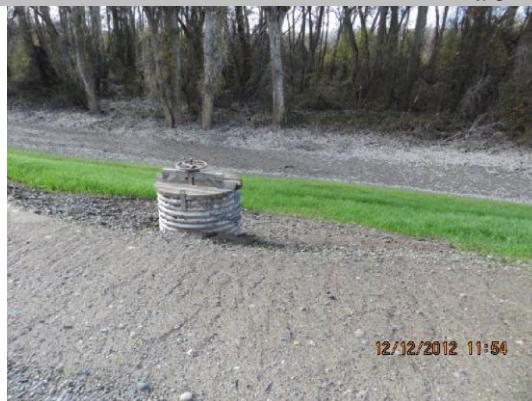
Photo 2 of 3 : UCIP_SP_2020_55545_47198.jpg

WS view: closer view of CMP riser

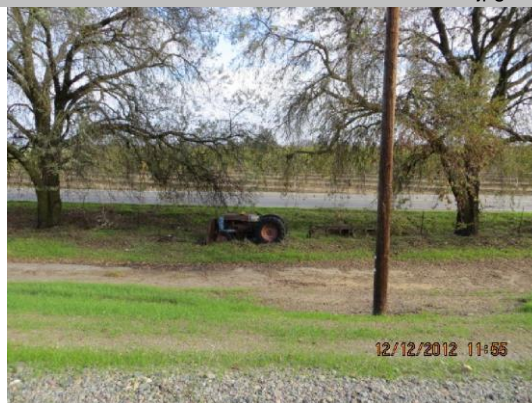
Photo 3 of 3 : UCIP_SP_2020_55545_47197.jpg

LS view: overview (no pipe)

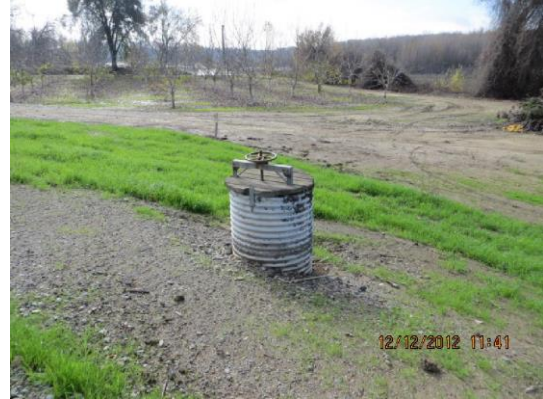
Photo 2 of 3 : UCIP_SP_2020_55547_47201.jpg

WS view: overview of CMP riser

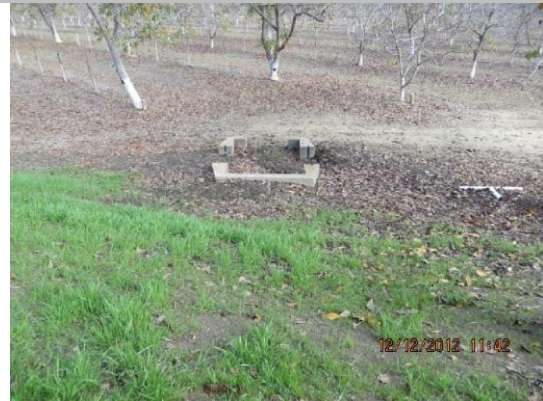
Photo 3 of 3 : UCIP_SP_2020_55547_47200.jpg

LS view: overview of concrete box

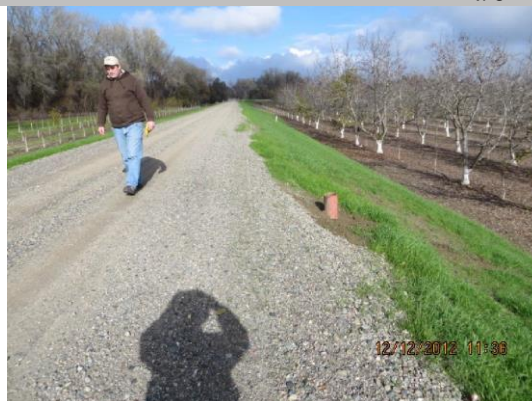
Photo 1 of 3 : UCIP_SP_2020_55549_47206.jpg

DS_ID:17338
FS_ID:55549
EP_NO: N/A
Repair Type: Non-Urgent
Crossing Status: Indicator Found
UCIP Comments: 07/31/2019 Record remains Non-Urgent; no permit has been found authorizing pipe through levee. DWR DMP geophysical investigation results did not find any conclusive evidence of pipe. The pipe through the levee is a non-metal pipe. Need to find owner to determine permit authorizing crossing through levee. (O. Magana - DWR UCIP)04/19/2017 Still only LS air vent found. (DWR Sutter Yard- Afreitag)10/31/2016 Only the LS standpipe and air vent found.06/01/2016 Still only the vacuum breaker on LS shoulder visible.04/01/2015 Only vacuum breaker found on LS shoulder.06/30/2014 Same as last inspection.12/18/2013 Same as last inspection.07/23/2013 Same as last inspection.
FIELD_STRUCT_DESC: Pipe of unknown diameter, purpose and material through the levee, at an unknown depth below the crown, not found. Vacuum breaker inside steel standpipe on the landside (LS) shoulder, found in 2015. [Additional Reference(s): DWR Levee Log, 2002].

WS view: overview

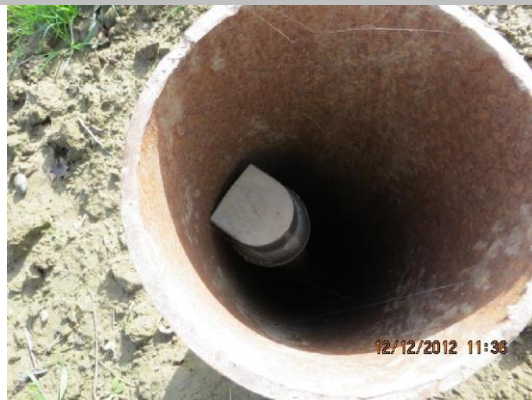
Photo 2 of 3 : UCIP_SP_2020_55549_47205.jpg

WS view: vacuum breaker inside a steel pipe

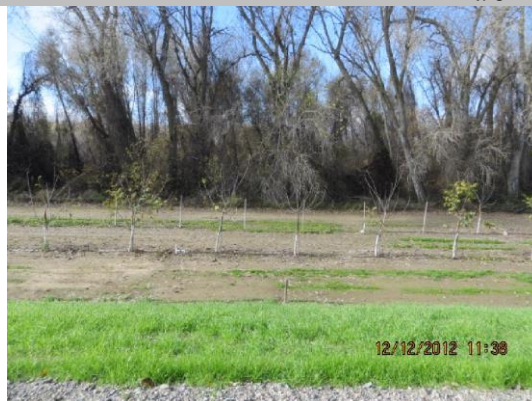
Photo 3 of 3 : UCIP_SP_2020_55549_47204.jpg

LS view: overview (no pipes)

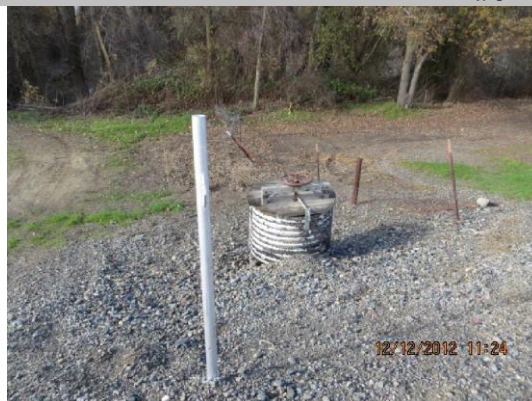
Photo 1 of 3 : UCIP_SP_2020_55550_47208.jpg

DS_ID:17295
FS_ID:55550
EP_NO: 9529
Repair Type: Non-Urgent
Crossing Status: Found
UCIP Comments: 07/31/2019 Record has been updated to from No Action Needed to Non-Urgent; internal inspection found some issues with the pipe. Pipe has been noted as abandoned since 2012. Recommend LMA prepare a contingency plan for increased inspections during high-water to identify any pipe integrity or levee integrity issues that might arise with abandoned pipe. Record will remain in UCIP's list as part of future inspections until the pipe is properly removed or abandoned according to Title 23 requirements. Need to clarify ownership for this crossing. (O. Magana - DWR UCIP)09/21/2017 Permit review indicates this 24-inch pipe was authorized as an irrigation and drainage pipe under ABO issued as Permit No. 9529, structure description was updated. Structure type logged as drainage. (DWR UCIP - O. Magana)
04/19/2017 Abandoned- needs to be done so properly. (DWR Sutter Yard- Afreitag)10/31/2016 Abandoned. (DWR Sutter Yard- Afreitag)06/13/2016 Pipe was exposed and camera inspected by Nor-Cal Pipeline Services 10/29/2015. Photos of the exposed pipe ends were uploaded on 4/1/2015. The internal inspection showed some signs of rust but no visible holes or deterioration were found. After the inspection the pipe ends were capped and reburied.06/09/2016 Khalida Fazel of UCIP requests that any photos of the pipe when it was exposed for a video inspection be kindly uploaded here.04/04/2016 Proper abandonment of pipe is needed. Pipe has been buried again after it was dug up and video inspected, so was not visible on LS. Note that landowner has regraded LS slope so drainage is now to the east (toward LS).04/01/2015 Both WS and LS pipe ends have been dug up in preparation for an internal camera inspection. Pipe shows signs of heavy rust and both ends of pipe are plugged with soil.06/30/2014 Same as last inspection.12/18/2013 Same as last inspection.07/23/2013 Same as last inspection.12/12/2012 Only a CMP riser with slide gate found on WS. (P. Amatya - DWR UCIP) FIELD_STRUCT_DESC: *ABANDONED* 24-inch irrigation and drainage pipe through the levee, invert 11.5 feet below the crown. Slide gate in a corrugated metal pipe (CMP) riser on the waterside (WS) slope. (24-inch pipe [HLM 8.55] authorized under Automatic Board Order (ABO) issued as Permit No. 9529, 1974 - Dorwood Ranching Co.) [Additional Reference(s): DWR Levee Log, 2002. USACE Sacramento O&M Manual 136, March 1960 (HLM 8.55)]

WS view: overview of CMP riser

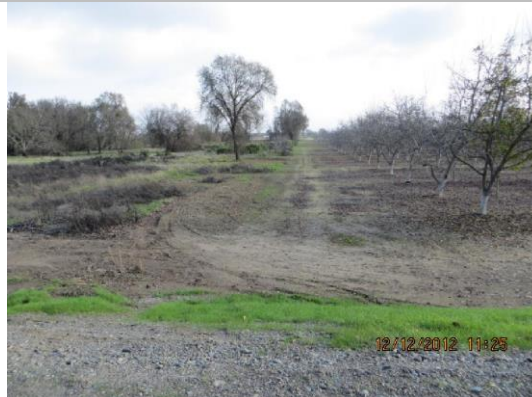
Photo 2 of 3 : UCIP_SP_2020_55550_47207.jpg

LS view: overview (no pipes)

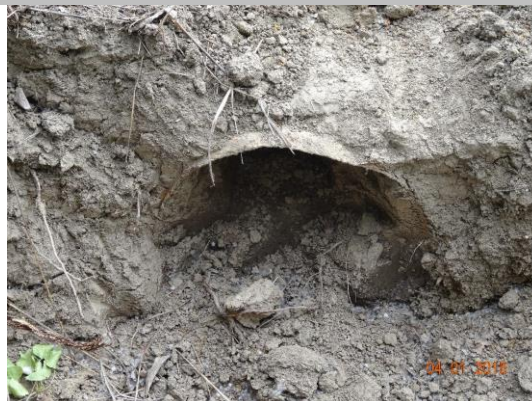
Photo 3 of 3 : UCIP_SP_2020_55550_73640.jpg

WS pipe end
